# A Case Study: Infrared Thermography Technique is An Essential Tool to Determine Energy Leakage from Failing Door Seals on Prototype Cold Storage

**Abstract**— A study was conducted to assess the efficiency of insulation in a prototype cold storage system by using phase change materials, aiming to detect energy loss through failing door seals and insulation panel integrity issues. Infrared thermography was used for this experimental investigation, utilizing thermographic images. The cold storage, with a volume of 606 liters, maintained internal conditions at 4°C temperature and 95% relative humidity, while surrounding ambient conditions were set at 42°C temperature and 75% relative humidity. Analysis concluded that a transmitted heat gain of 202.3 Kcal from walls and doors during daylight hours, highlighting significant energy losses attributed to failing door seals.

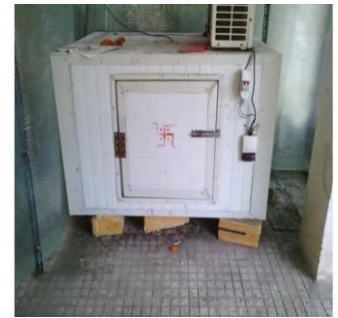
Fig 2(b) Prototype cold storage

According to Fig. 2 (a, c, d, e, and f) shows some typical cases of door issues and energy leakages from cold areas. Gaps around door are major problem in this study. Fig. 2 shows blue images of the cold storage is specific locations, which indicate significant heat loss through door and failure of seals. Fig.2 (a) and Fig.2 (b) are the front view images of the door. Fig 2(c) and Fig.2 (d) clearly illustrates

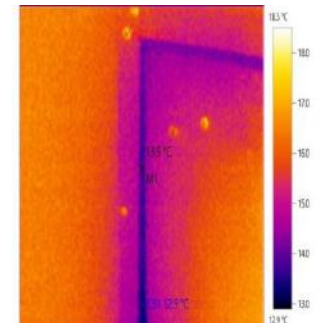
Fig 2(d) top left corner

that the air leakages at bottom left corner side and top left corner side of the door. Fig.2 (e) again demonstrated completed dark blue lines, which means cold areas, the air leakages from bottom right corner area of the door and seal failure issue in prototype cold storage. It is also observed that Fig.2 (f) demonstrated energy losses from the refrigerant pipe of the refrigerant system. The cold spot temperature was measured 11.9<sup>0</sup>C with the reflected temperature is 20<sup>0</sup>C and the emissivity is 0.95 in the image Fig.2 (a). The cold spots were measured 11.4<sup>0</sup>C and 12.9<sup>0</sup>C with the reflected temperature is 20<sup>0</sup>C and the emissivity is 0.95 in the image Fig.2 (c) bottom left corner and Fig.2 (d) top left corner respectively. The cold spots were measured 13<sup>0</sup>C and 20.9<sup>0</sup>C with the reflected temperature is 20<sup>0</sup>C and the emissivity is 0.95 in the image Fig.2 (e) bottom right corner and Fig.2 (f) refrigerant pipe respectively.
